Analysis Report - 2000-1994			
	Customer Name:		Purchase Order:	
	Part Number:	MAX831CWE	Lot/Date Code:	
	Manufacturer:	MAXIM	Devices Received:	5

Summary Of Inspection Results

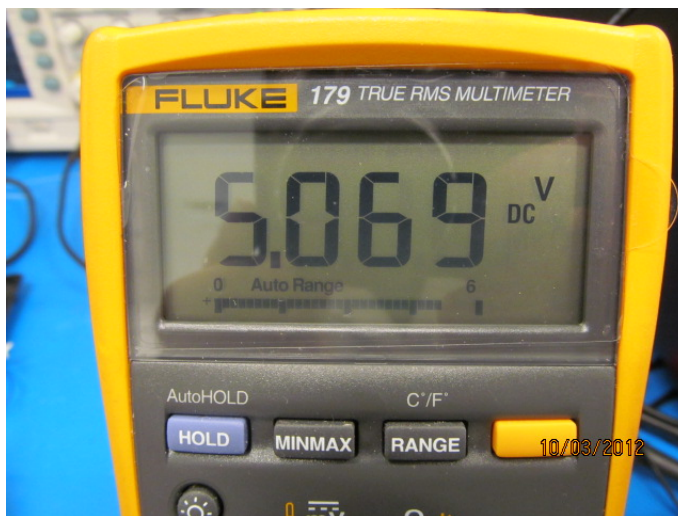
Figure 24. VOUT16WNOSHUTTDOWNPASS

Feed in 20.0Vdc to Vin (pins 1, 2, 3 and 4)

Output is measured as 5.0Vdc as expected for MAX831 device.

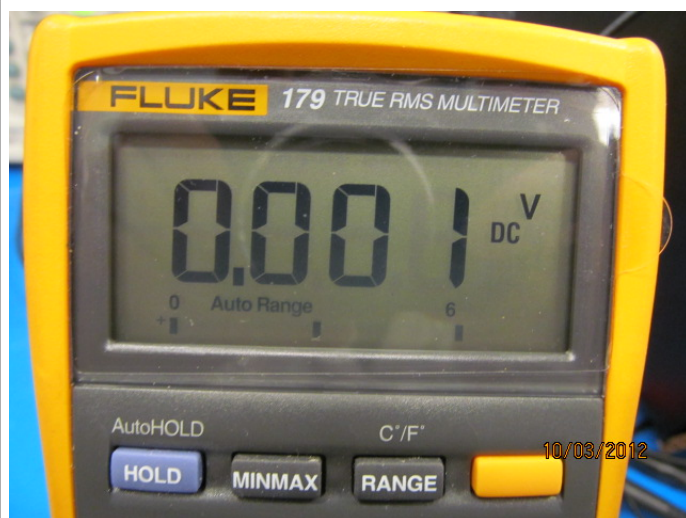
Figure 25. VOUT16WSHUTDOWNPASS

Verified when pin 9 (Shut) is tied to Low, the DUT is shut down as expected (0V at Output)
